# POPULAR LOG FLUME RIDE MAKES A SPLASH WITH MACHINED PPS

## HOW AIP REDUCED A WATER RIDE'S OVERHAULS ROUGHLY 25X

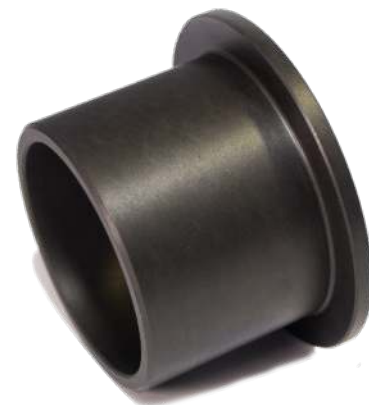
By precision machining the bushings instead, the components could meet the precise tolerances and finishes demanded by the speed and load of the log flume.

The previous bronze bushings required roughly **25x the overhauls** of the new PPS bushings. Overall, the change in materials not only saved on maintenance and inventory costs, but improved guest satisfaction with the increase in uptime.

AIP worked diligently with the ride engineers to ensure the bushings were built to the exact specifications of the water ride. Due to the grade of PPS chosen, the only methods available for manufacturing the bushings were machining or injection molding. By precision machining the bushings instead, the components could meet the precise tolerances and finishes demanded by the speed and load of the log flume.

AIP's established relationship with Quadrant gave the client access to the supplier's high-quality PPS grade for their wheel bushings. A massive benefit of the machined PPS bushings was the reduction in ride downtime. The previous bronze bushings required roughly **25x the overhauls** of the new PPS bushings. Overall, the change in materials not only saved on maintenance and inventory costs, but improved guest satisfaction with the increase in uptime.
